Facilities Maintenance Operations (FMO) now offers Motor Shaft Grounding, a maintenance program that prevents bearing failure and significantly extends motor life.

The Blackstone Case Study

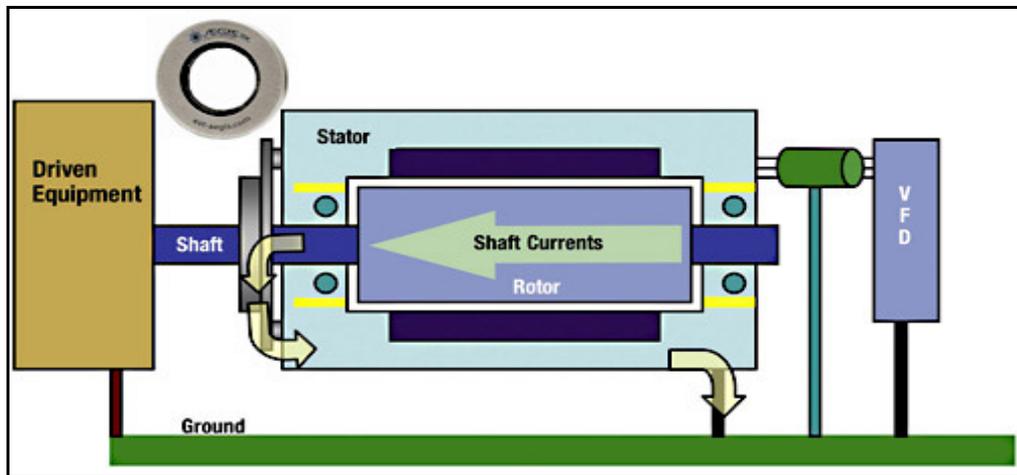
All Variable Frequency Drives (VFD) controlling AC motors develop Induced Shaft Currents that discharge through the bearings (illustration #1). During this process, arcing between the ball bearings and the outer wall of the bearings causes fluting (illustration #2) which will eventually lead to bearing failure.

Illustration #1: Currents discharging through the bearings

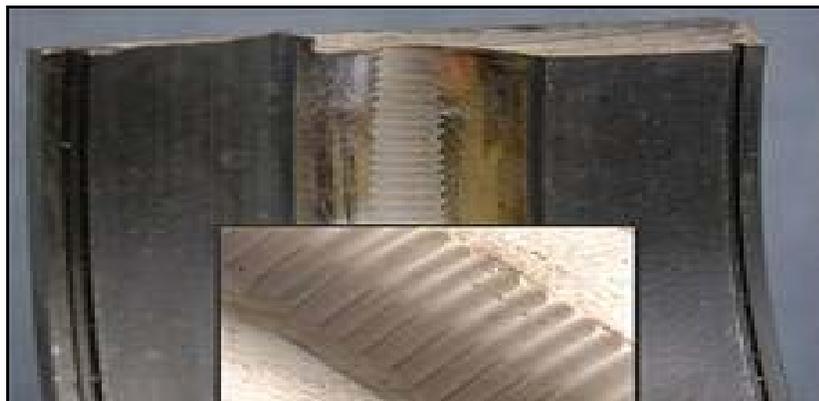
Typically, motor manufacturers estimate that a motor will last between 30,000 - 40,000 operating hours. However, fluting can reduce this life expectancy by up to 50%.

Illustration #2: Damage to the bearing wall caused by arcing

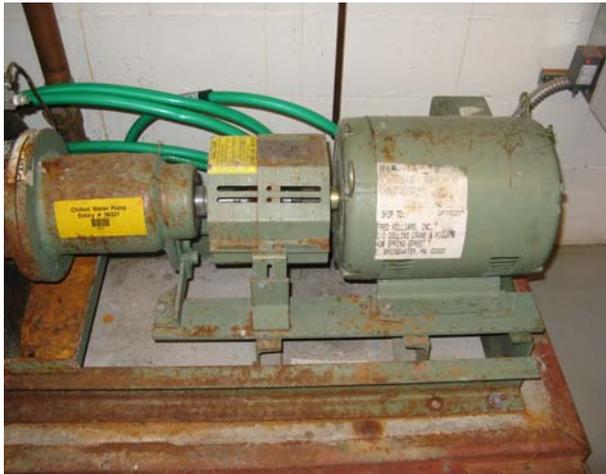
Illustration #3: Motor # 1, Blackstone South, Chilled Water Pump P-1

Baldor Cat # EM3311T
Spec # 37F6144663
7.5 HP
230/460 Volts
20/10 Amps
1760 RPM
213T Frame
OBSB enclosure
S # F0507221640
Pump P-2 is similar with serial # F0507221505

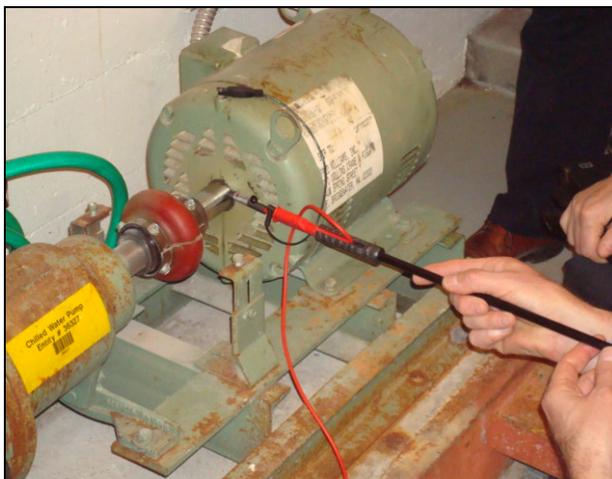
FMO monitored and recorded the voltage on the motor shaft of the chilled water pump in Blackstone South (illustration #3) using an AEGIS probe and oscilloscope. The probe, which has a high density conductive micro-fiber tip, was placed directly on the rotating shaft with the motor running (illustration #4).

Illustration #4: The AEGIS probe placed directly on the motor shaft

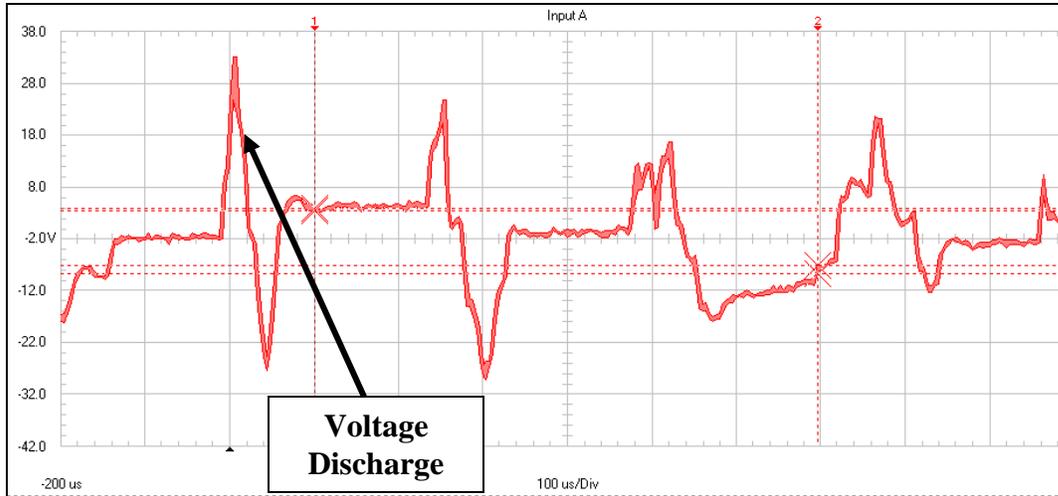
The graph below illustrates a steady discharge of harmful shaft voltages. As you'll notice later in Step 4, the absence of these voltages would result in a flat-line reading.

Illustration #5: Test results from Motor # 1 without a Shaft Grounding Ring.

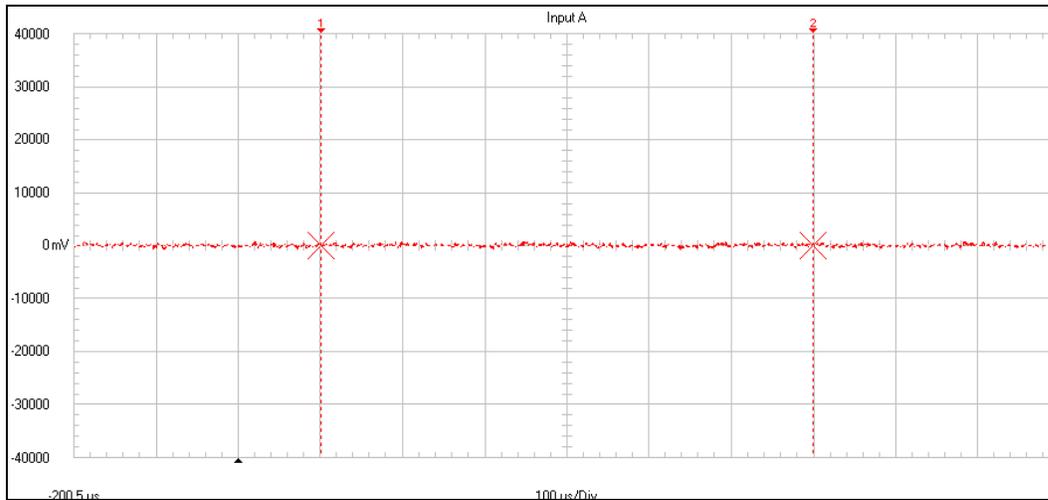
FMO monitored and recorded the voltage on the motor shaft after the AEGIS Grounding Ring was installed. As outlined in Illustration #6, the voltage traveling through the motor shaft was eliminated.

Illustration #6: Motor #1 with a Shaft Grounding Ring
